CSX Kanawha Trestle Inspection Report Charleston, West Virginia

Michael Baker Jr., Inc.

August, 2011

**UNDERWATER INSPECTION
OF
KANAWHA TRESTLE
KANAWHA RIVER PIERS
IN
CHARLESTON, WEST VIRGINIA**

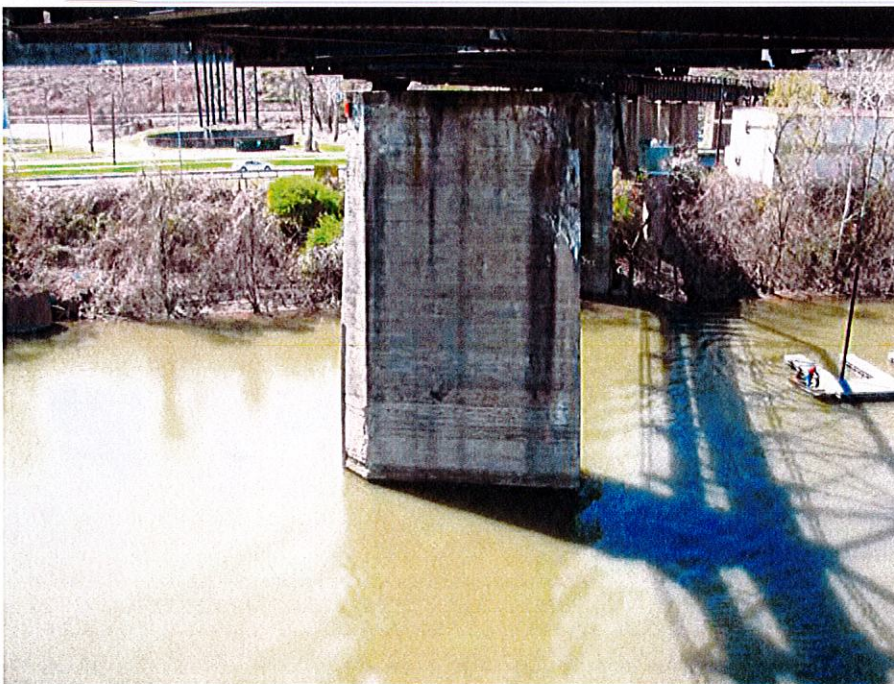
Figure 2 *Typical River Pier*

1. The river piers are made of poor quality concrete by today's standards and are deteriorated significantly. The strength of the core samples revealed a concrete strength of approximately 1500 to 2500 psi in the upper portion of the pier shafts. Although chloride contamination does not seem to be a problem, the concrete strength and the condition of the piers in the upper 15 to 20 ft of the shaft beneath the truss bearings is in poor condition and exhibits concrete spalls up to 1 ft deep and extensive delamination, cracks and discoloration due to deteriorating concrete (See Photos 1-4 and Appendices). In addition to the deteriorated concrete, no reinforcing steel was found in the piers. Spalls and cores up to 12" deep at random locations did not encounter any rebar. As a result, significant strengthening will be required. Wrapping the piers with carbon fiber sheets is one possible method of strengthening the piers (Items 32 to 36 in the attached estimate).

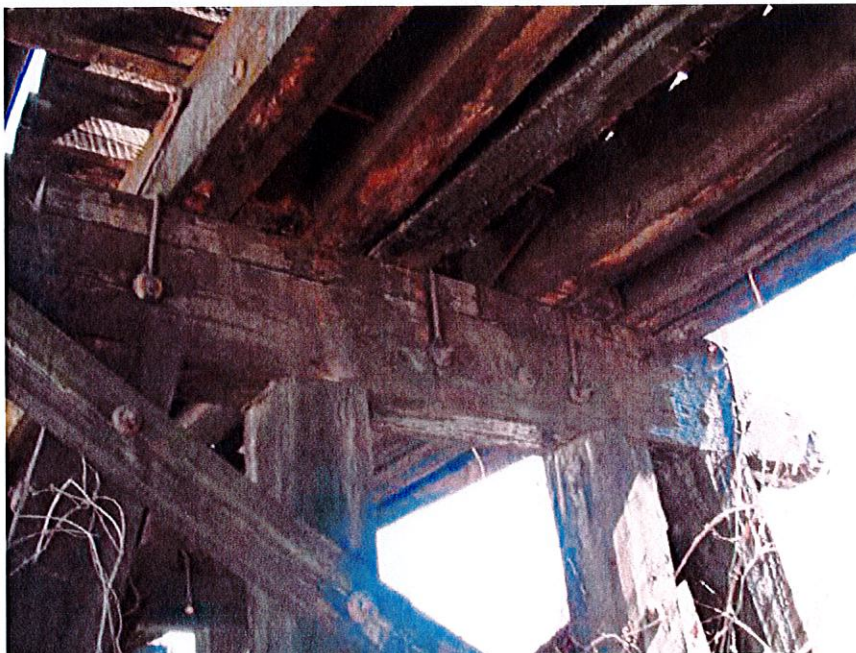
Figure 2 *Typical View of Timber Bent*

4. The bearing shims on top of the bent caps are crushed or rotten in multiple locations (See Photos 2,3, & 6). These shims should be replaced and they are quantified in item #16 and item #50 on the cost estimate.

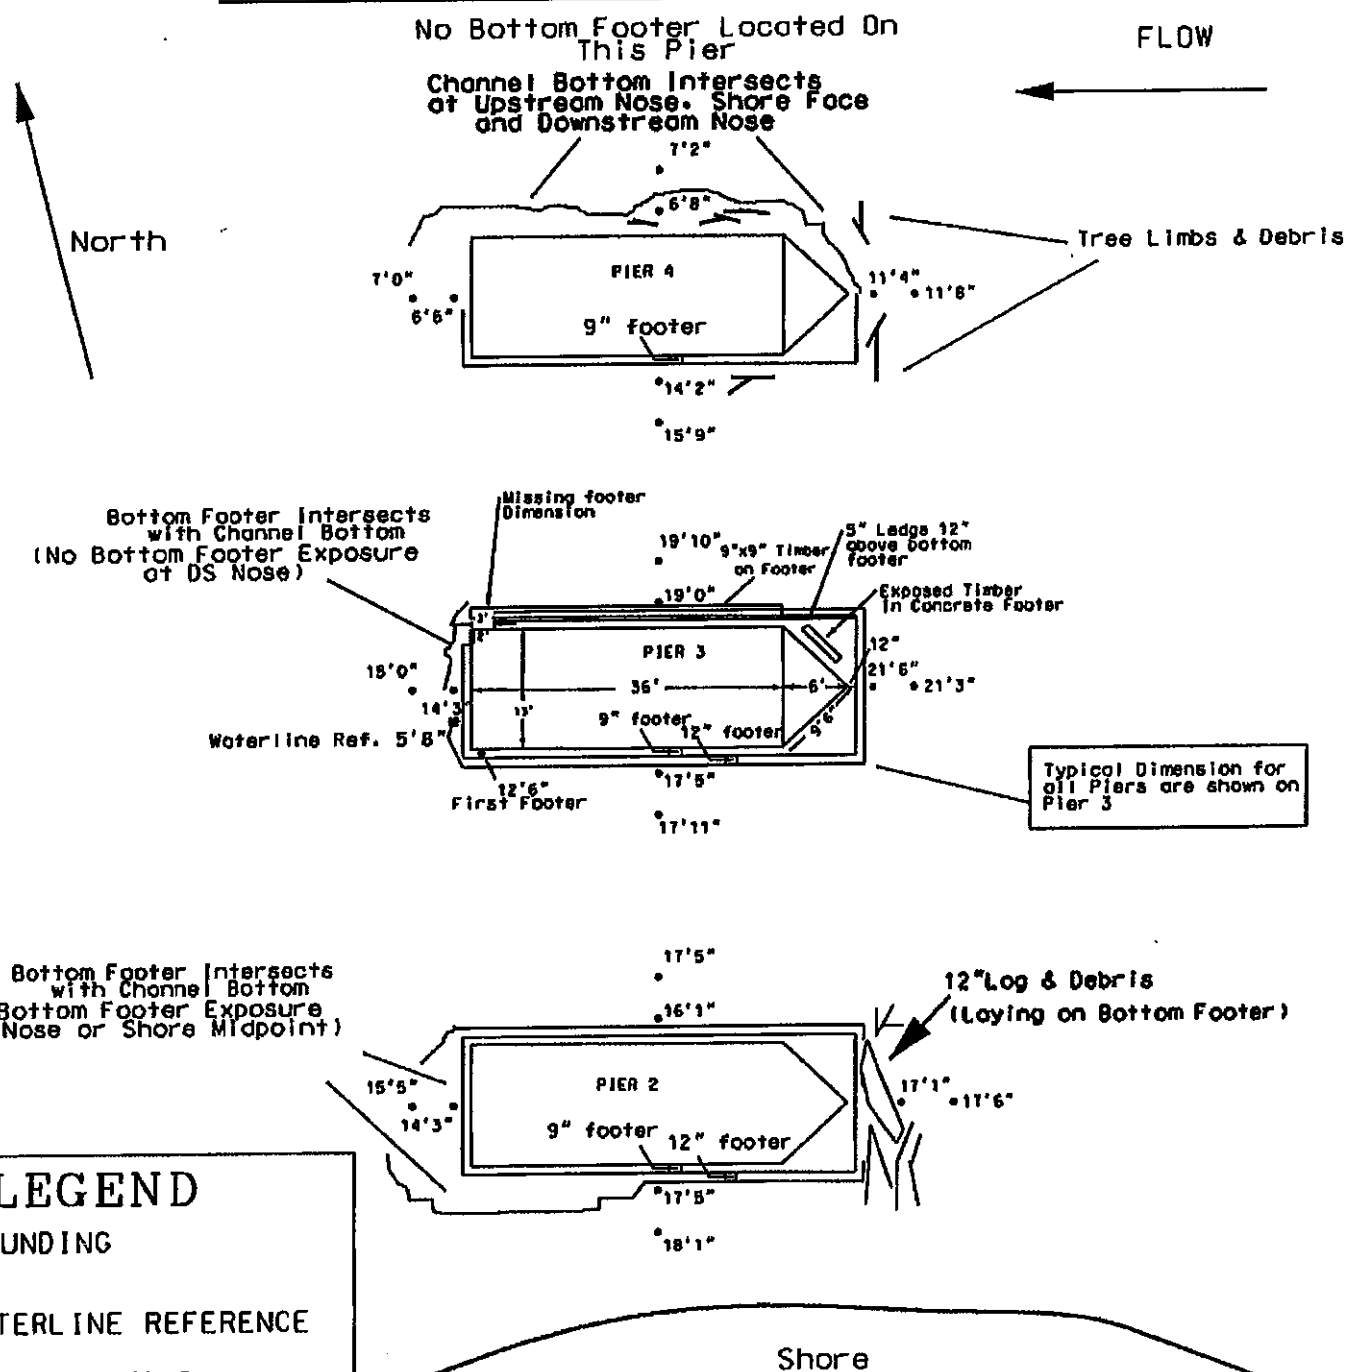
FIGURE 2

- 2.4 At some places there were large timbers that appeared to be formwork that was left in place.
- 2.5 Dimensions, soundings, and other pertinent information are shown in Figure 1 and Figure 2. Soundings were taken immediately adjacent to each pier and approximately six feet out into the river channel from each pier or, if it is exposed, from the edge of the pier footing.

- 2.7.5 No fractures were noted on this pier, although a large void was noted about one-third of its length downstream, shore side corner. See Figure 2. The void in the concrete appeared about 6 inches from the channel bottom. It was 12 inches high, 4 feet long, and 2 feet deep.

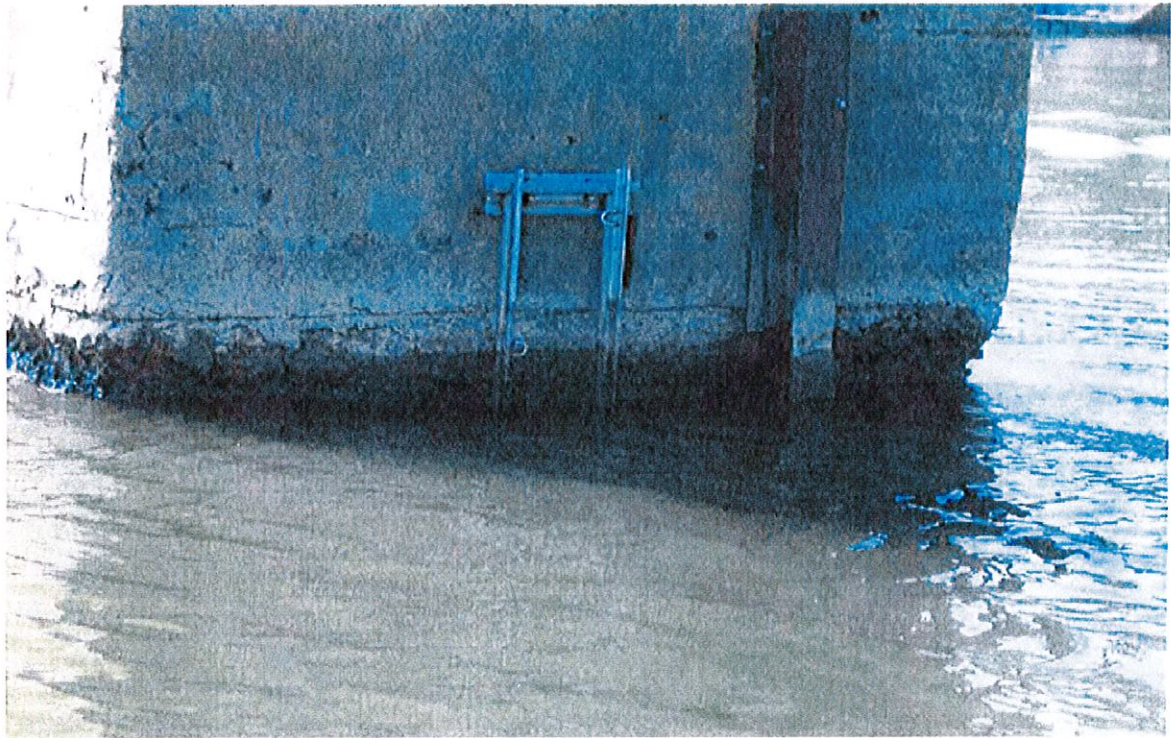
Figure 3. Waterline reference located on the downstream nose of Pier 3
